Seismic Risk Assessment El Mirador 1820 Avenida del Mundo, Coronado, CA 92118

May 2010

Project Number: 2365670

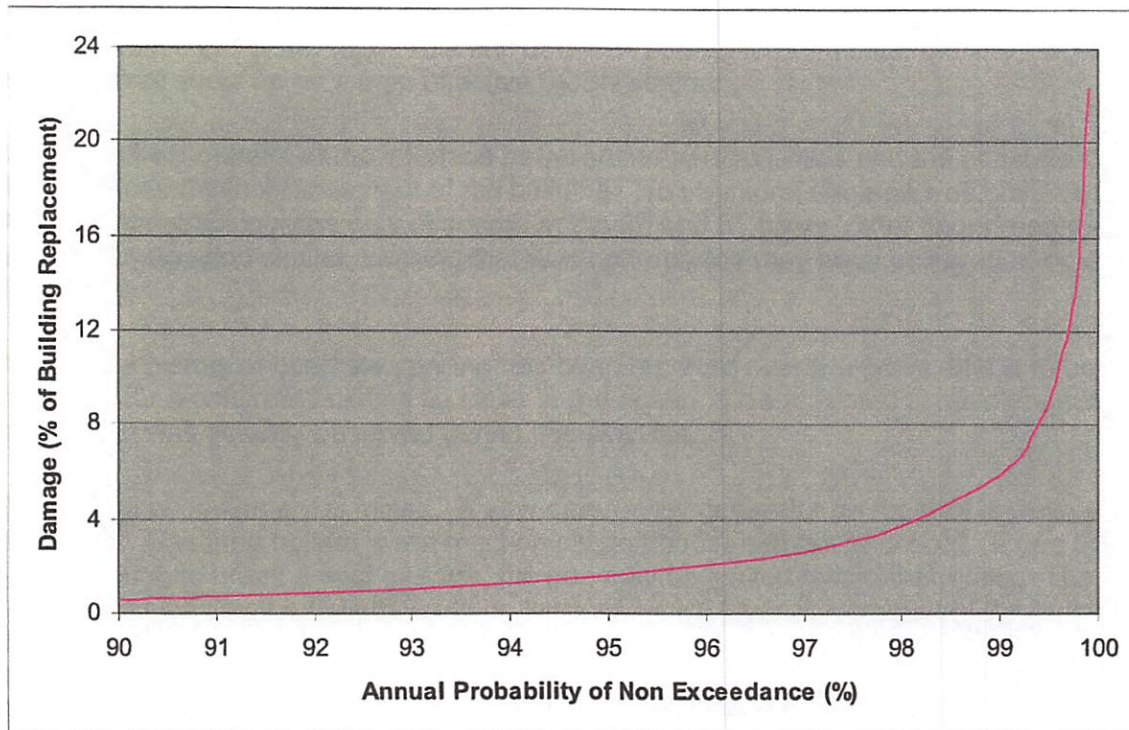
Figure 4-1 – Annual Aggregate Damage and Loss Distribution

Figure 4-1 shows probabilistic losses for other non-exceedance percentages, which can be translated into other return periods for the building. The 99.80% probability of not exceeding a 15% loss in any given year is the 500 year return and the 99.00% probability of not exceeding a 6% loss in any given year is the 100 year return. 90% probability of non-exceedance is approximately a ten year return. This graph does not include demand surge for this building or the contingency for cleanup and recovery.
